# Inspection Report

## **L.A.Selleck inspections and Consulting**

Olathe, KS. 66062

**1 Report Information****Client Information**

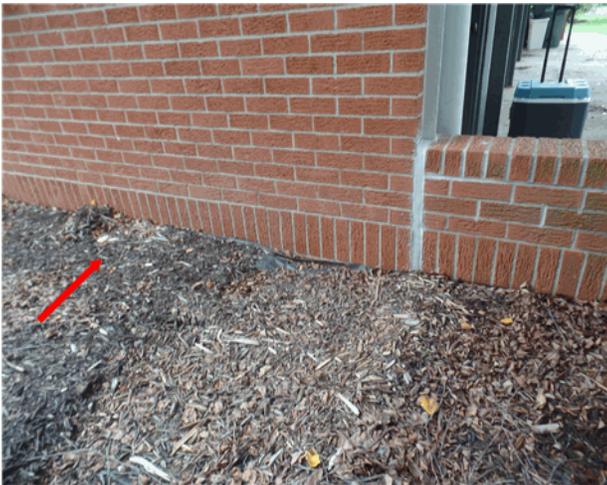
The soil level was high on the foundation. I recommend clearing soil away from exterior walls areas, to provide a minimum of 6+ inches between wall coverings and grade. Conditions observed are conducive to wood destroying insect infestation and / or moisture related problems.

Soil is high on the foundation.

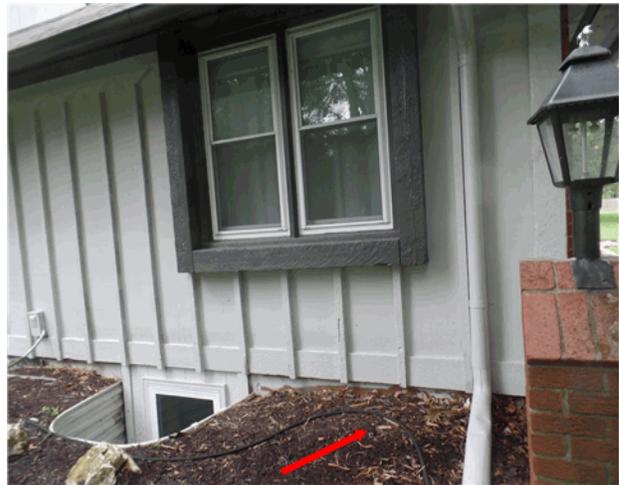
Sump pump discharge at front of home disconnected. Water discharges next to foundation. Recommend repair. Sump pumps are discharged under ground with no observable clean outs. Clogged discharge lines can build pressure and cause pipe failure as was observed. Recommend discharging sump pumps above ground and away from the foundation.

Recommend 4 - 6 inch clearance soil or mulch to the siding. Sump pump discharge pipe disconnected. Water draining next to the foundation.

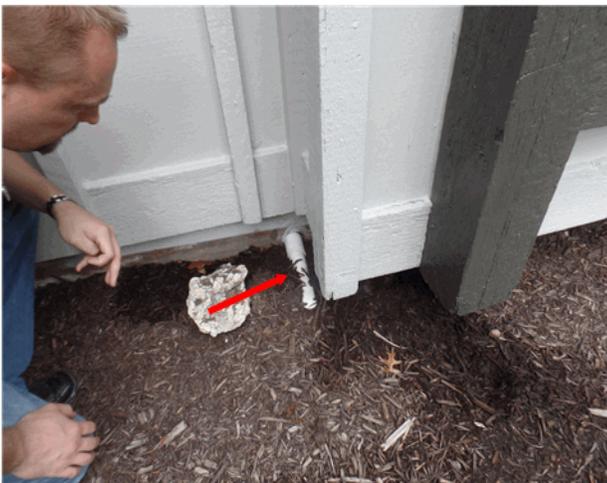
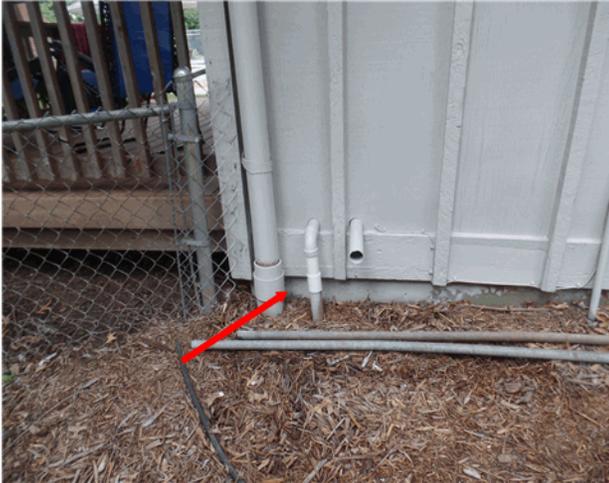
Sump pumps discharge into the yard with no clean out. Recommend routing above ground.

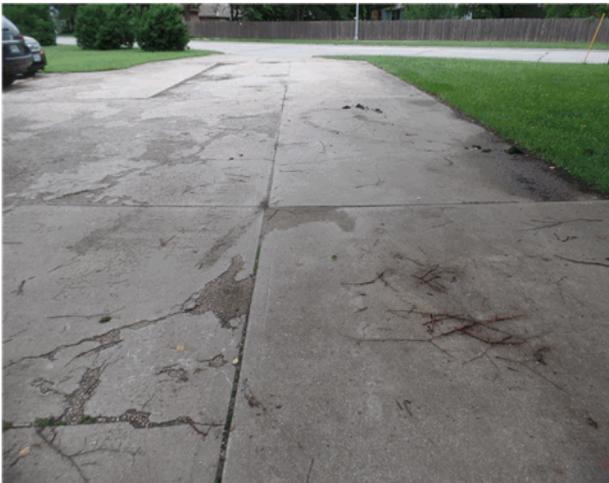
The driveway appears to be approaching the end of its useful life. The driveway had cracks and some settlement was observed. Potential tripping hazards were observed on the driveway. These should be repaired for safety.

Cracks and deterioration of the driveway observed.

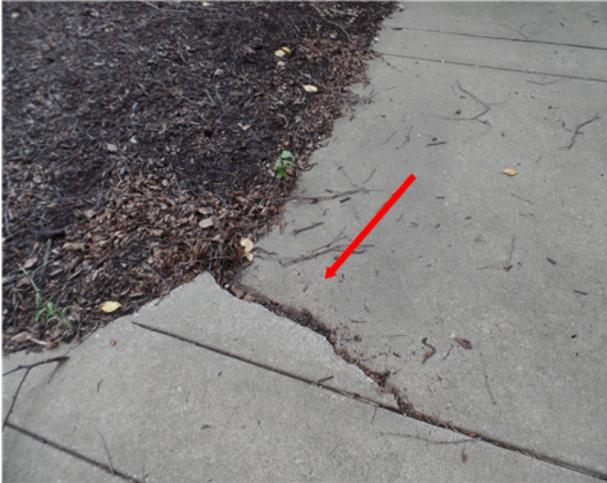
The sidewalk was cracked and raised or settled. This may cause a tripping hazard and should be repaired for safety.

Sidewalk trip hazard observed.  
Recommend repair for safety.

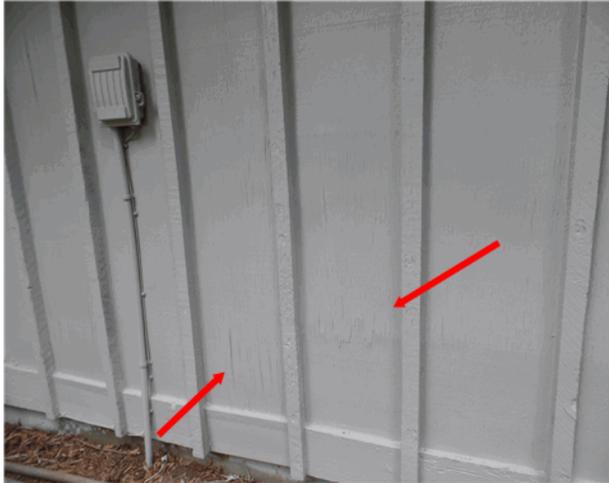
Some siding delamination observed.

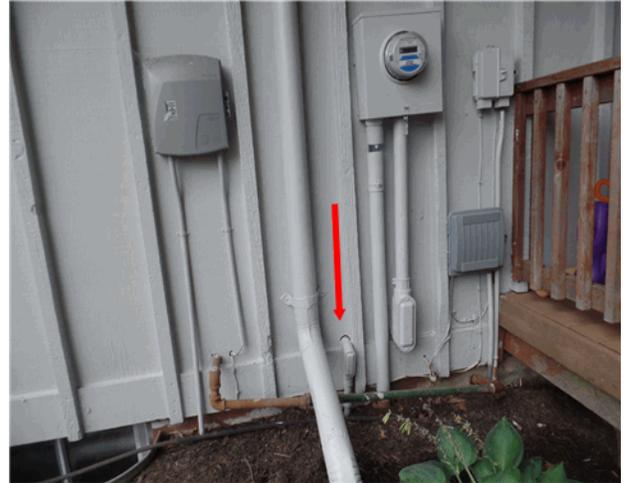
Seal around penetrations.

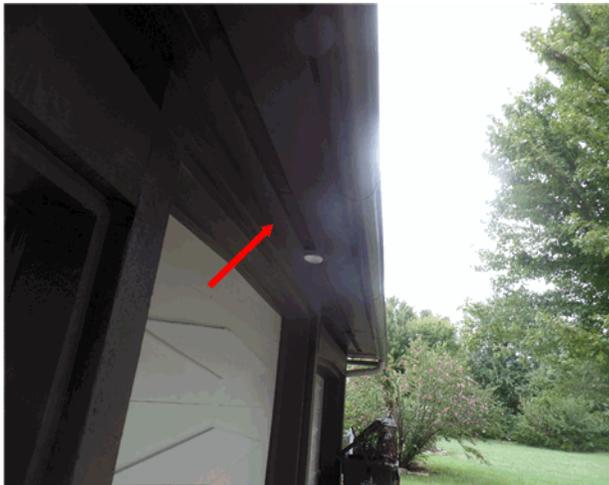
Some of the soffit vent screen has deteriorated.

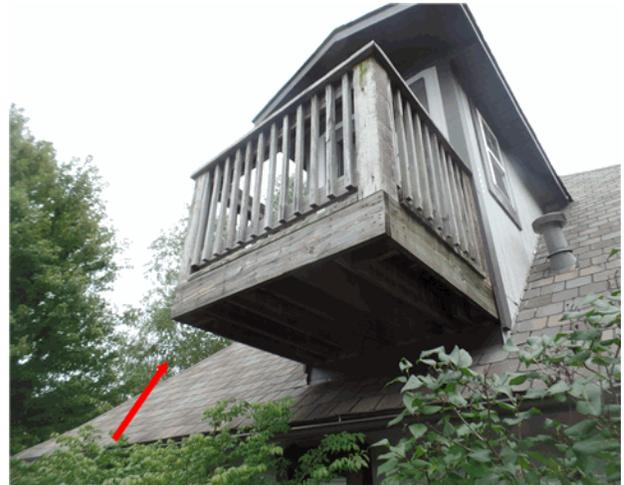
Upstairs balcony is over spanned. Recommend support.

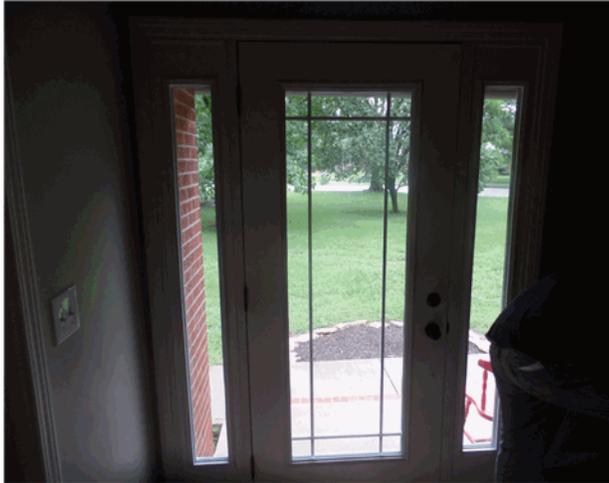
Entry door needs adjustment.

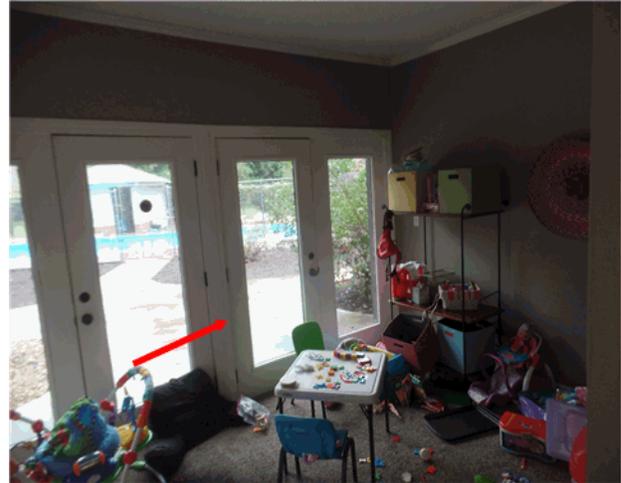
East sunroom door needs adjustment or repair.

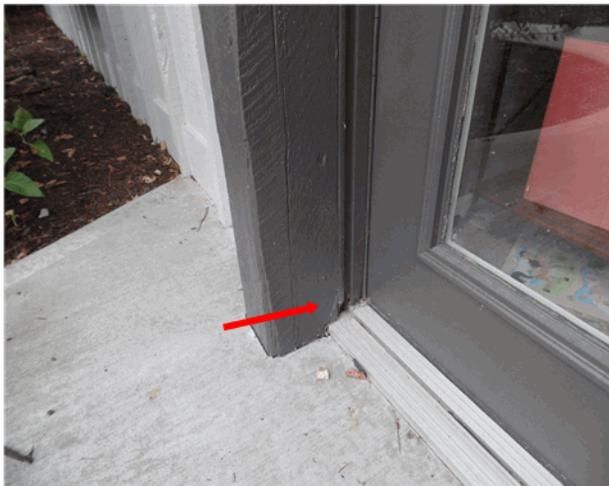
Moisture damage at the base of the sun room door.

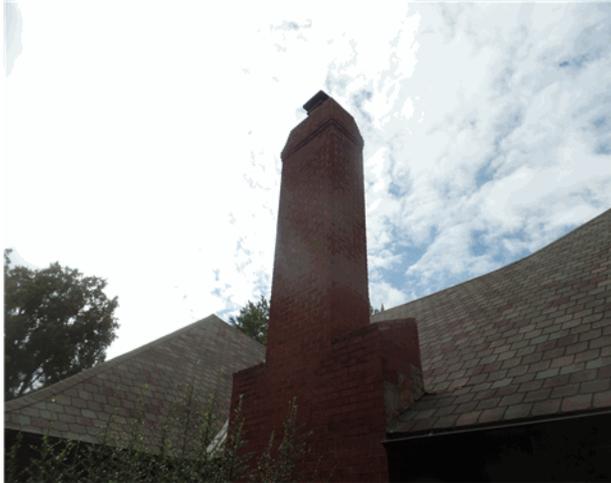
The visible and accessible portions of the chimney(s) appeared to be in serviceable condition at the time of the inspection. Recommend contacting a chimney sweep to clean chimney and inspect and clean the fireplace.

Recommend chimney cleaning and further inspection.

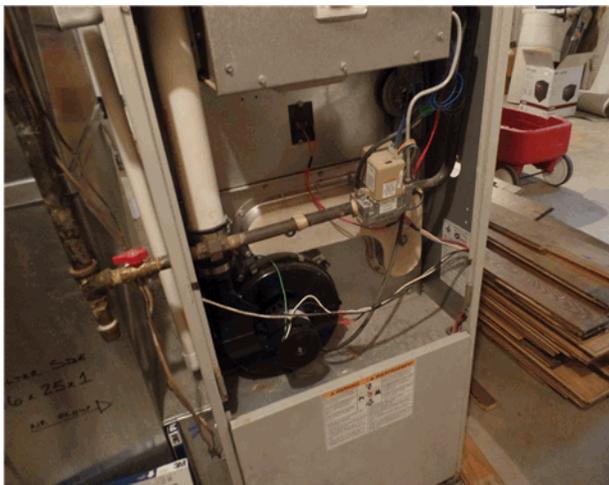
<b>17) Unit Observations</b>	Zoned heating system. The manufacturer date of the furnaces was Aug. 2000. Most manufacturers claim the life expectancy of a unit to be 15 - 20 years. At that point repairs or replacement can be expected. The furnaces were in serviceable condition at the time of the inspection.
------------------------------	--

The furnaces are about 18 years old. Expect repairs or replacement at this age.

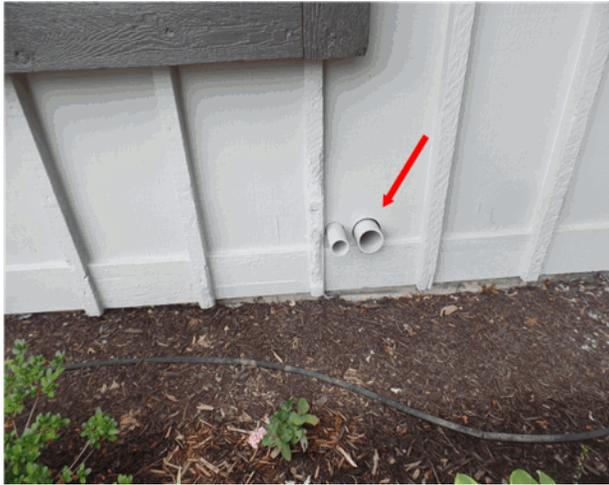
The furnace flues, both units, exhaust outside the home is too close to the air intake to the furnace. Recommend routing vent away from the exhaust. Recommend contacting an HVAC contractor for further evaluation and repair.

Furnace flue exhaust too close to furnace air intake. Seal penetrations to prevent water intrusion.

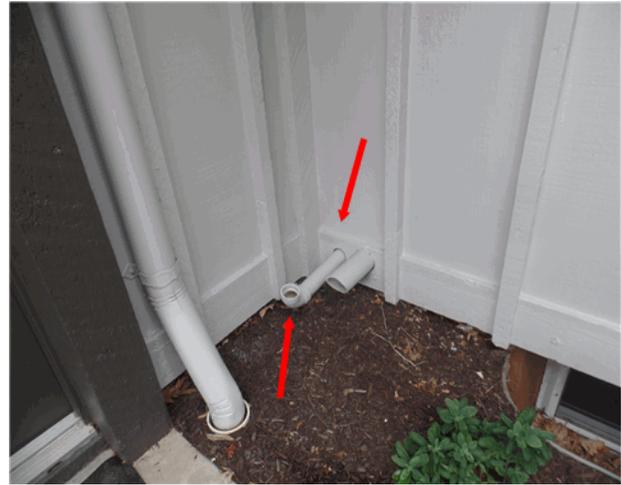
Improperly routed furnace exhaust and air intake. Rain can enter the furnace.

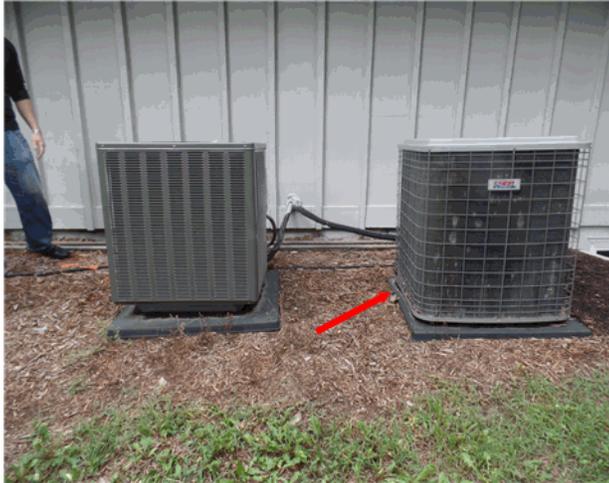
Two units. The left AC unit (MFG. date June 2012) appeared to be in serviceable condition at the time of inspection. This is not an indication of future performance. The Right AC unit (Mfg. date: June 2000) was making a noise at the time of the inspection. Recommend contacting a HVAC contractor for further evaluation and repair of the unit.

Right AC unit making a noise.  
Recommend repair.

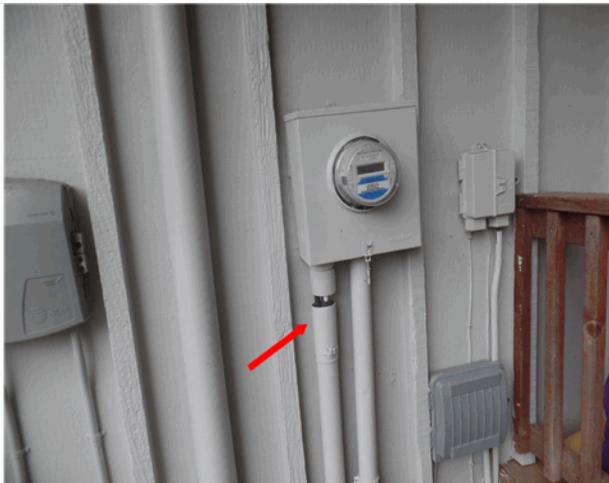
**22) Electrical Service Observations**      The conduit covering the electric power lines has settled. Recommend repair.

Electric service conduit has settled and should be repaired.

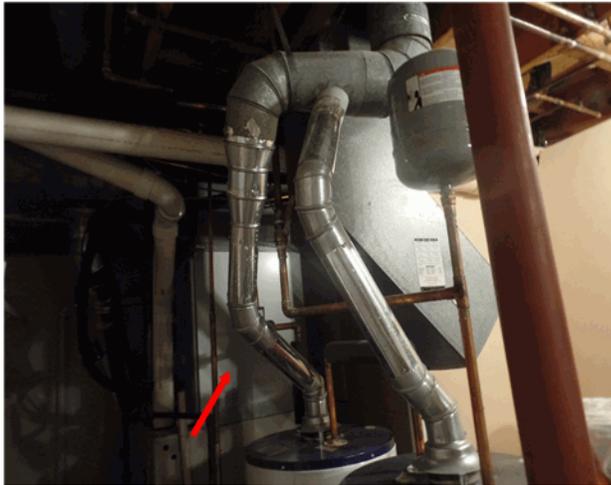
**28) Water Heater Observations**      There was a water leak of undetermined source, possibly the roof, coming from the hot water heater flues.

Water leaking from the hot water heater flues.

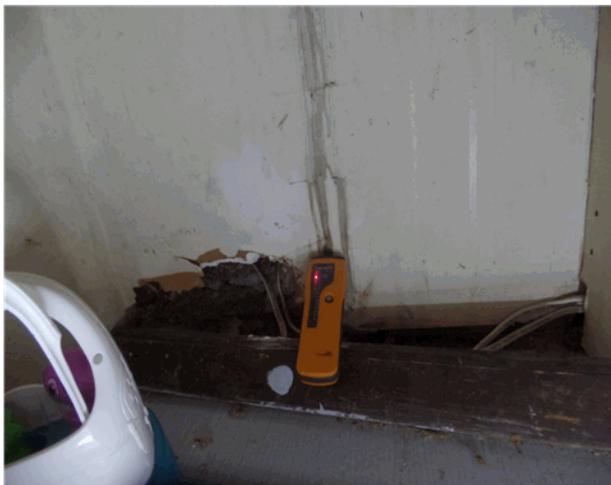
**29) Wall Observations**      There is a hole in the wall in the sun room closet that has an active leak. Recommend repair. The general condition of the interior walls appeared to be in serviceable condition at the time of the inspection.

Active leak, moisture detected in the sunroom closet.

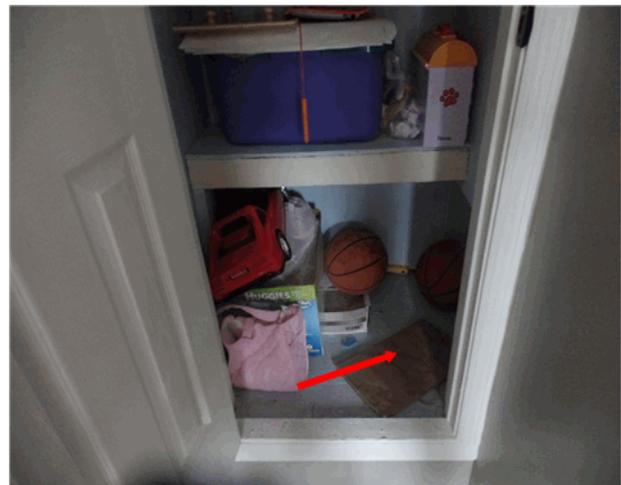
Active leak and wall repair needed in sunroom closet.

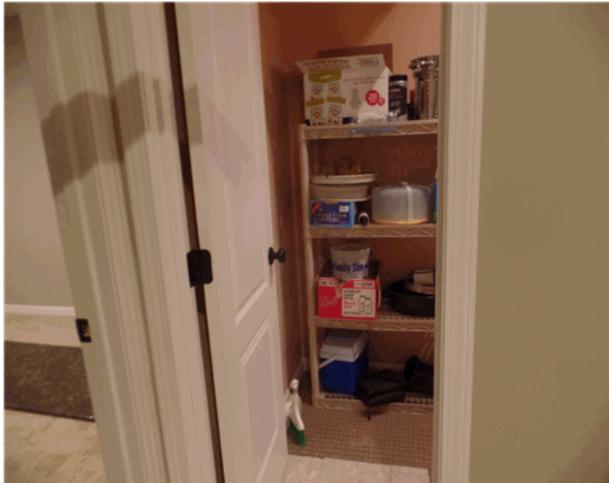
Basement hallway closet door needs adjustment or repair.

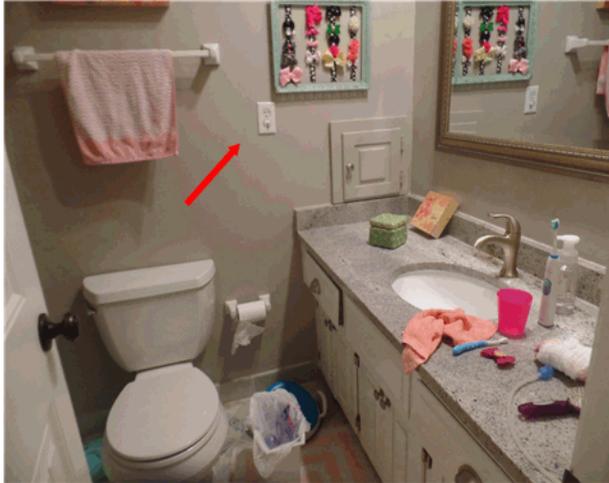
- 48) Electrical Observations** The half bath is not GFCI protected.  
The hall bath electrical outlet shows no ground when tested and is not GFCI protected.

No ground or GFCI protection when tested in hall bath.

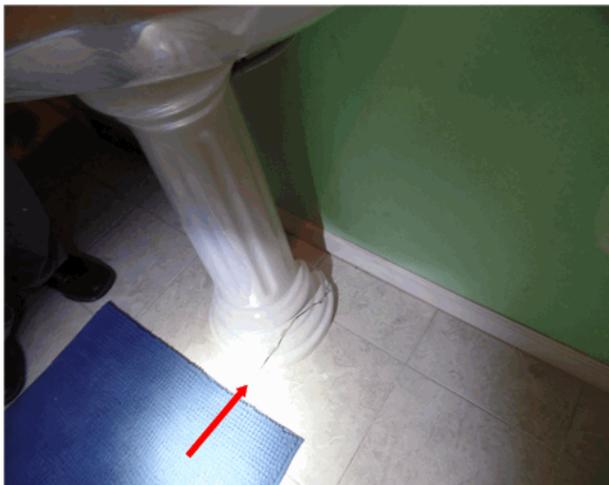
The sink pedestal in the garage bathroom is broken.

The sink in the garage bathroom pedestal is broken.

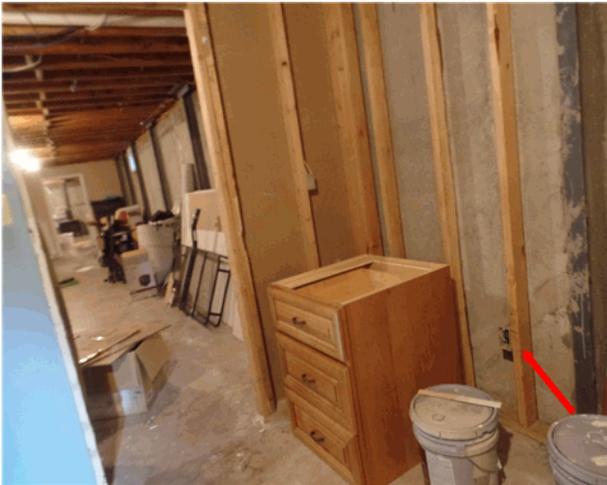
There was an open live junction box in the unfinished basement bedroom East side. Recommend cover.

Electrical junction box needs a cover in the East unfinished bedroom.

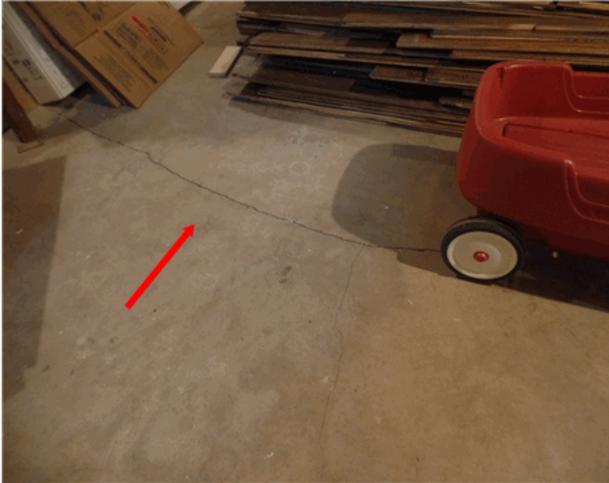
There were crack in the basement floor over 1/4". It appears that has been addressed with the foundation repairs by piercing under one of the columns. Recommend monitoring the floor cracks and sealing.

Cracks in the basement floor of over 1/4". Recommend sealing and monitoring.

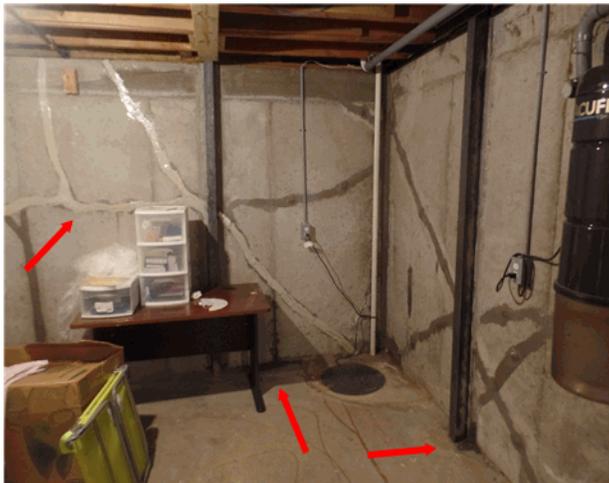
The North and West basement foundation walls have failed and have been repaired with steel columns and epoxy on the cracks. Some of the epoxy has cracked and will need to be repaired. It was raining at the time of the inspection and water was coming through the wall. I recommend contacting a foundation repair contractor to further evaluate the foundation and make needed repairs.

Water was coming in the basement and epoxy repairs were cracking and will need repair.

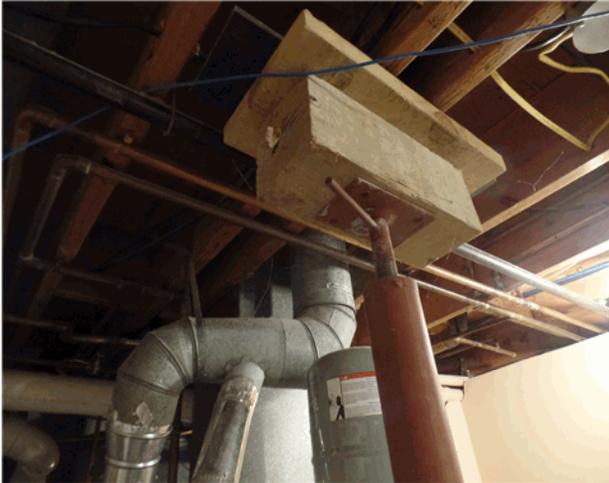
The adjustable columns supporting the main floor should be bolted / secured to the basement floor. The visible and observable areas of the floor's wood framing appeared to be in serviceable condition at the time of the inspection.

The adjustable columns should be secured above and at the basement floor.
